NEW MEXICO ENVIRONMENT DEPARTMENT

Re: Chevron Mining, Inc. (CMI), Questa Mine; Major Individual Permit; SIC 1061; NPDES Compliance Evaluation Inspection (CEI); NM0022306; July 24 thru July 26, 2018

**Chevron Mining Inc. - Questa Mine
NPDES Permit No. NM0022306
Compliance Evaluation Inspection
July 24 thru 26, 2018**

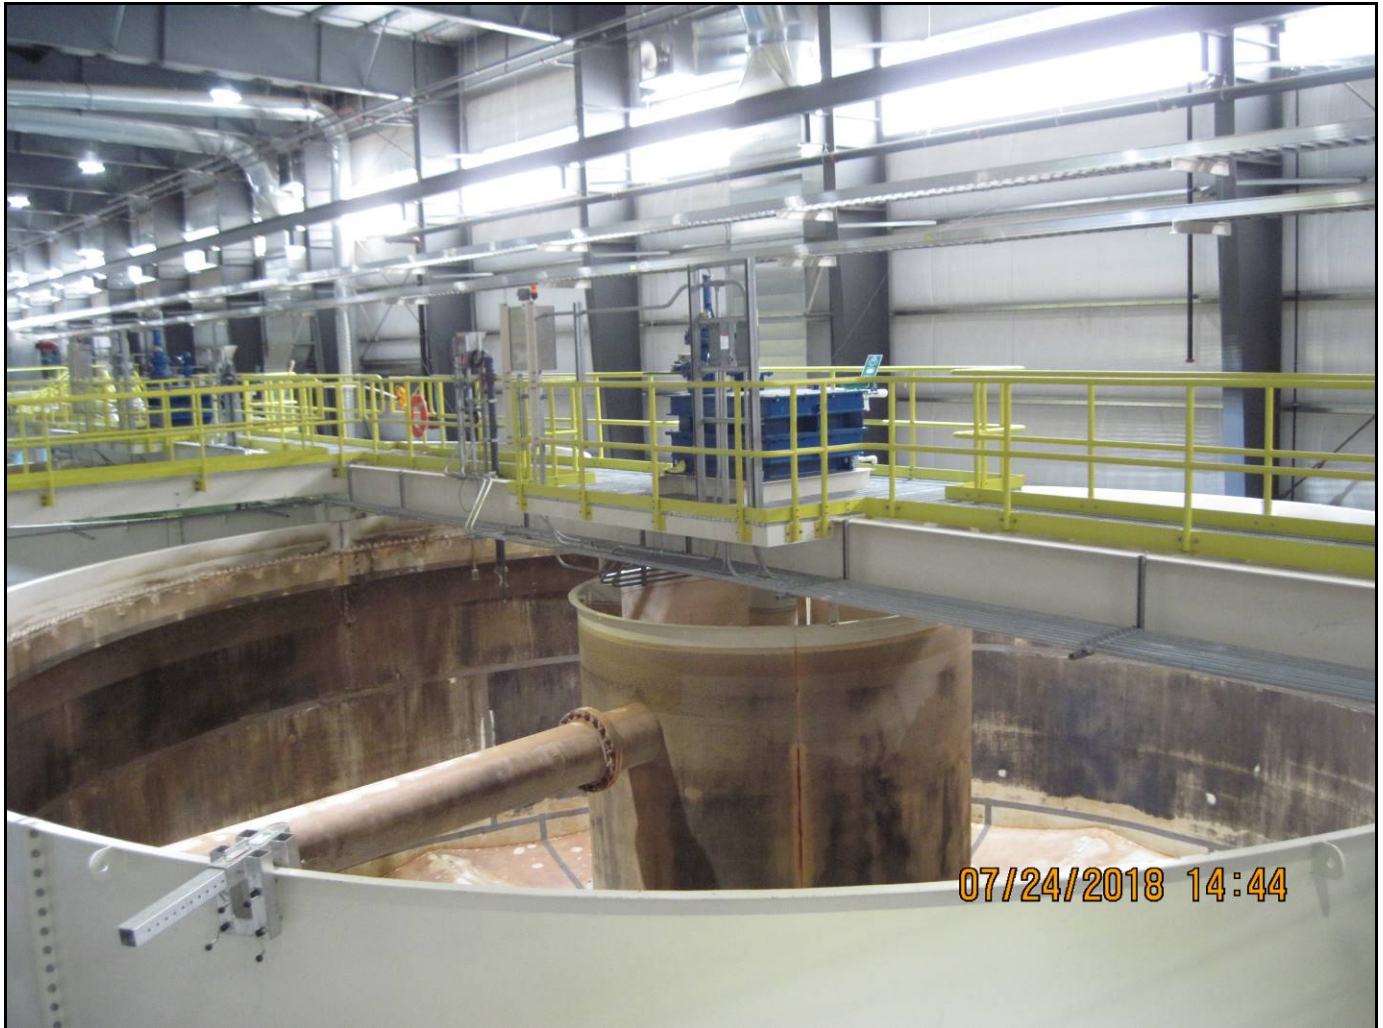
Location: CMI Questa Mine, Water Treatment Plant, Mine Site

Subject: Example of tank that was described by Permittee Representative to be offline waiting for repair / re-coating to prevent corrosion.

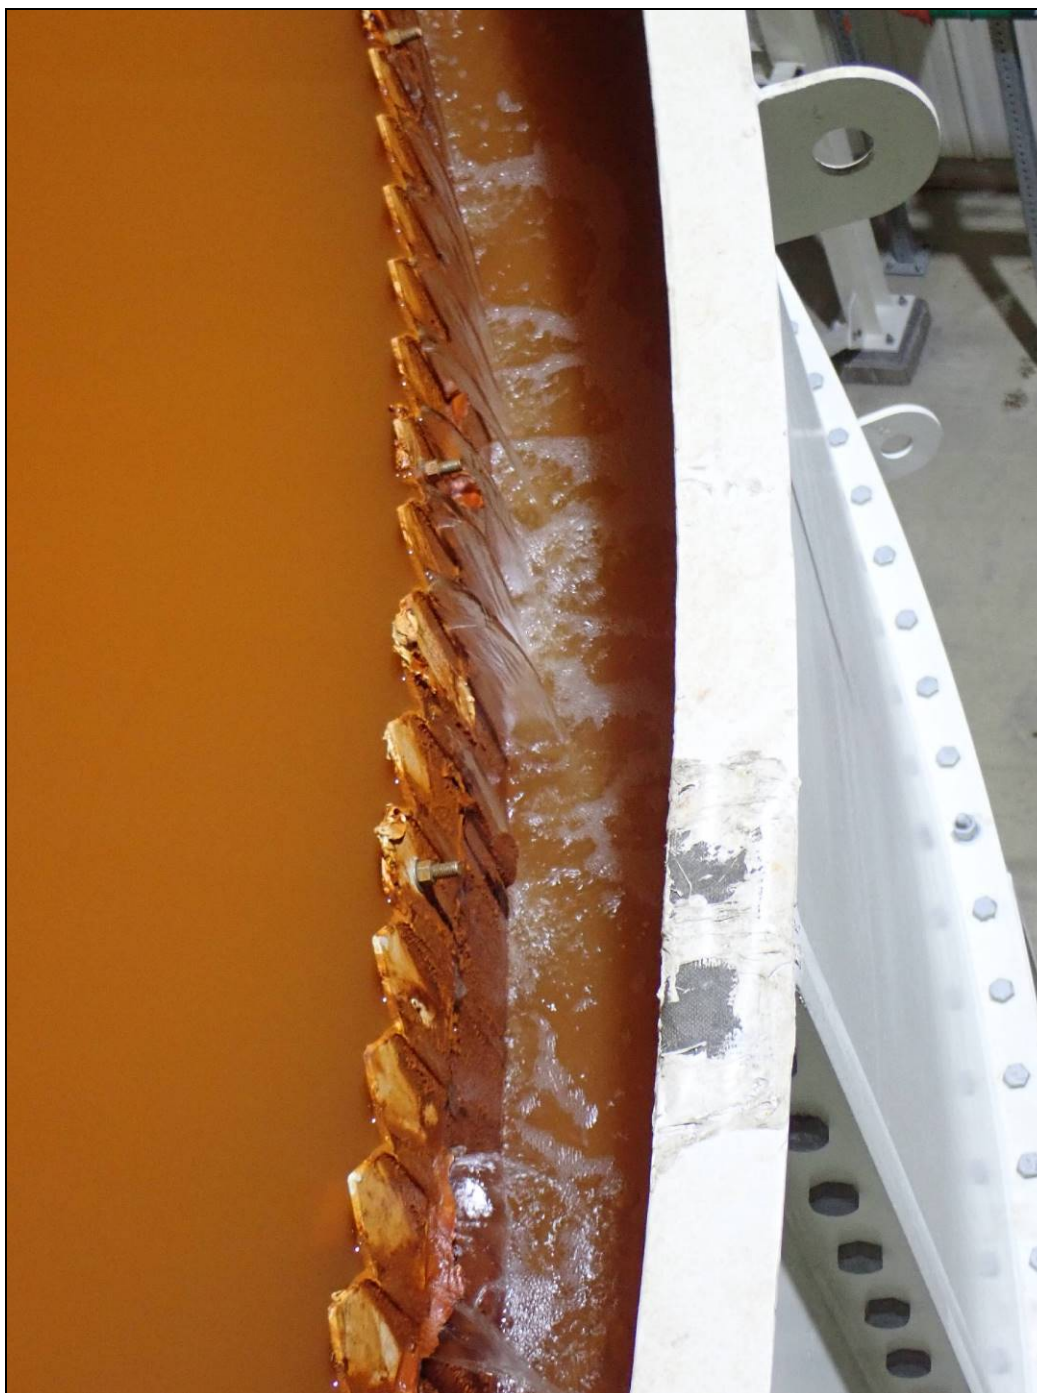
**NMED/SWQB
Official Photograph Log
Photo # 2**

Location: CMI Questa Mine, Water Treatment Plant, Mine Site

Subject: Example of buildup on circular clarifier weir. Water flow over weir was not distributed equally. WTP operators described how limited access around the clarifiers / clarifier weir affected maintenance and removal of buildup. Removal was done with water hoses and brushes. A design criterion for weirs is the weir overflow rate (e.g., gallons over each foot of weir each day). Buildup at weir teeth can cause short-circuiting, poor settling and uneven sludge blanket buildup.

2. TREATMENT UNITS PROPERLY MAINTAINED. See Photo Documentation for WTP Clarifier Weir	<input type="checkbox"/> S <input checked="" type="checkbox"/> M <input type="checkbox"/> U <input type="checkbox"/> NA

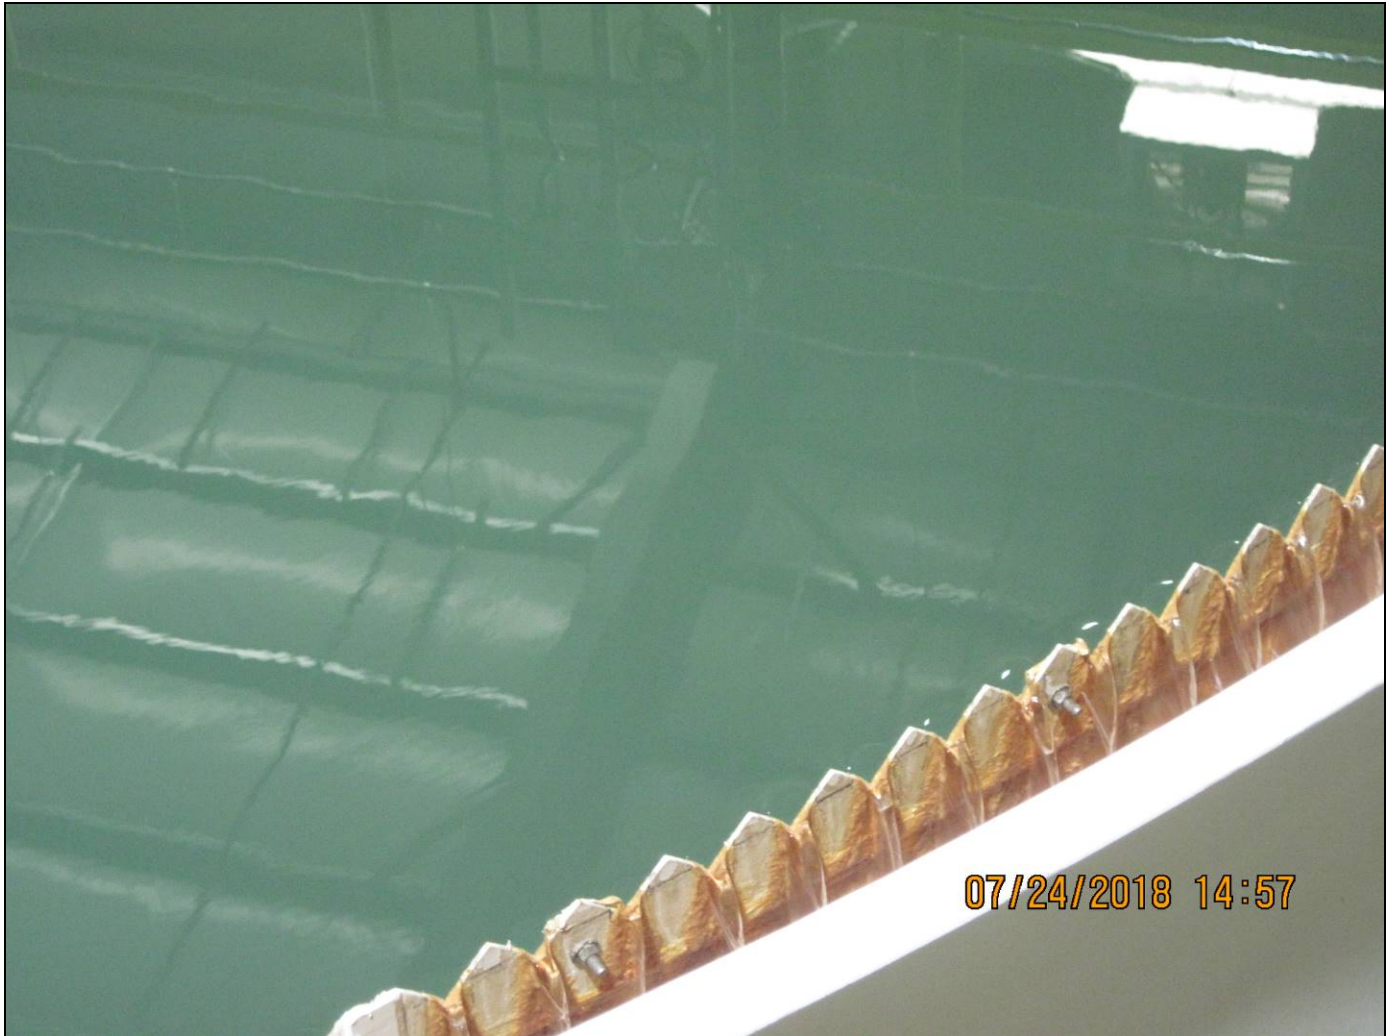
**NMED/SWQB
Official Photograph Log
Photo # 3**

Location: CMI Questa Mine, Water Treatment Plant, Mine Site

Subject: Another example of a circular clarifier with weir build up / precipitate.

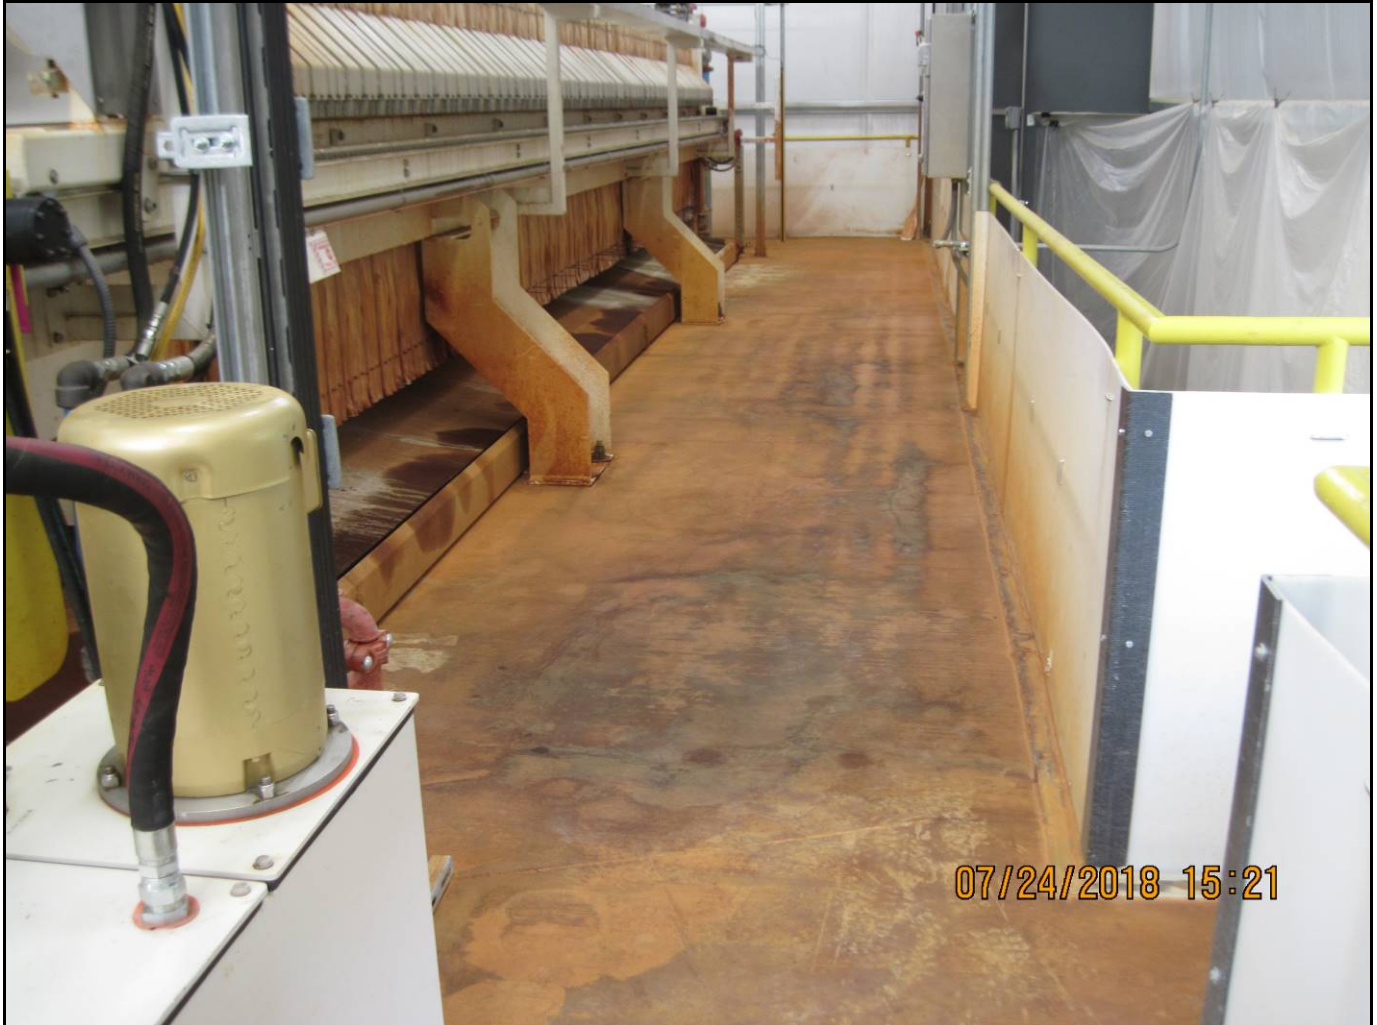
**NMED/SWQB
Official Photograph Log
Photo # 5**

Location: CMI Questa Mine, Water Treatment Plant, Mine Site

Subject: Staining and hairline cracks were observed on the concrete floor around the ICP low pH Filter Press.

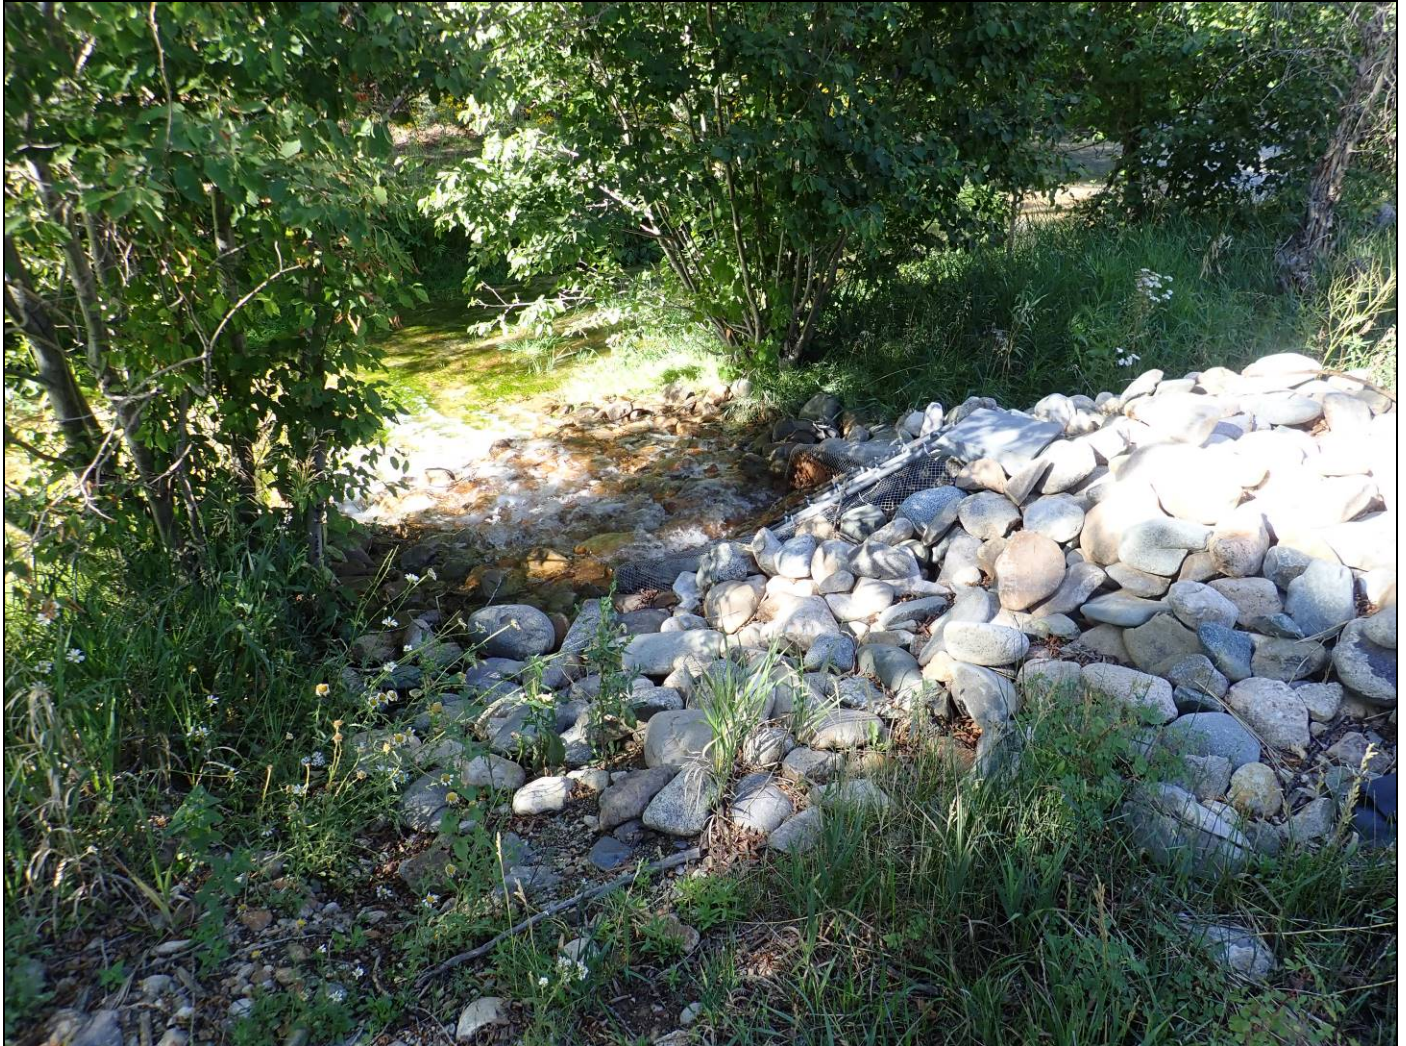
**NMED/SWQB
Official Photograph Log
Photo # 6**

Location: CMI Questa Mine, Water Treatment Plant, Mine Site

Subject: Looking south toward Red River from highway NM 38 right of way, rock rip rap, culvert pipe outlet and flow at Outfall 001.

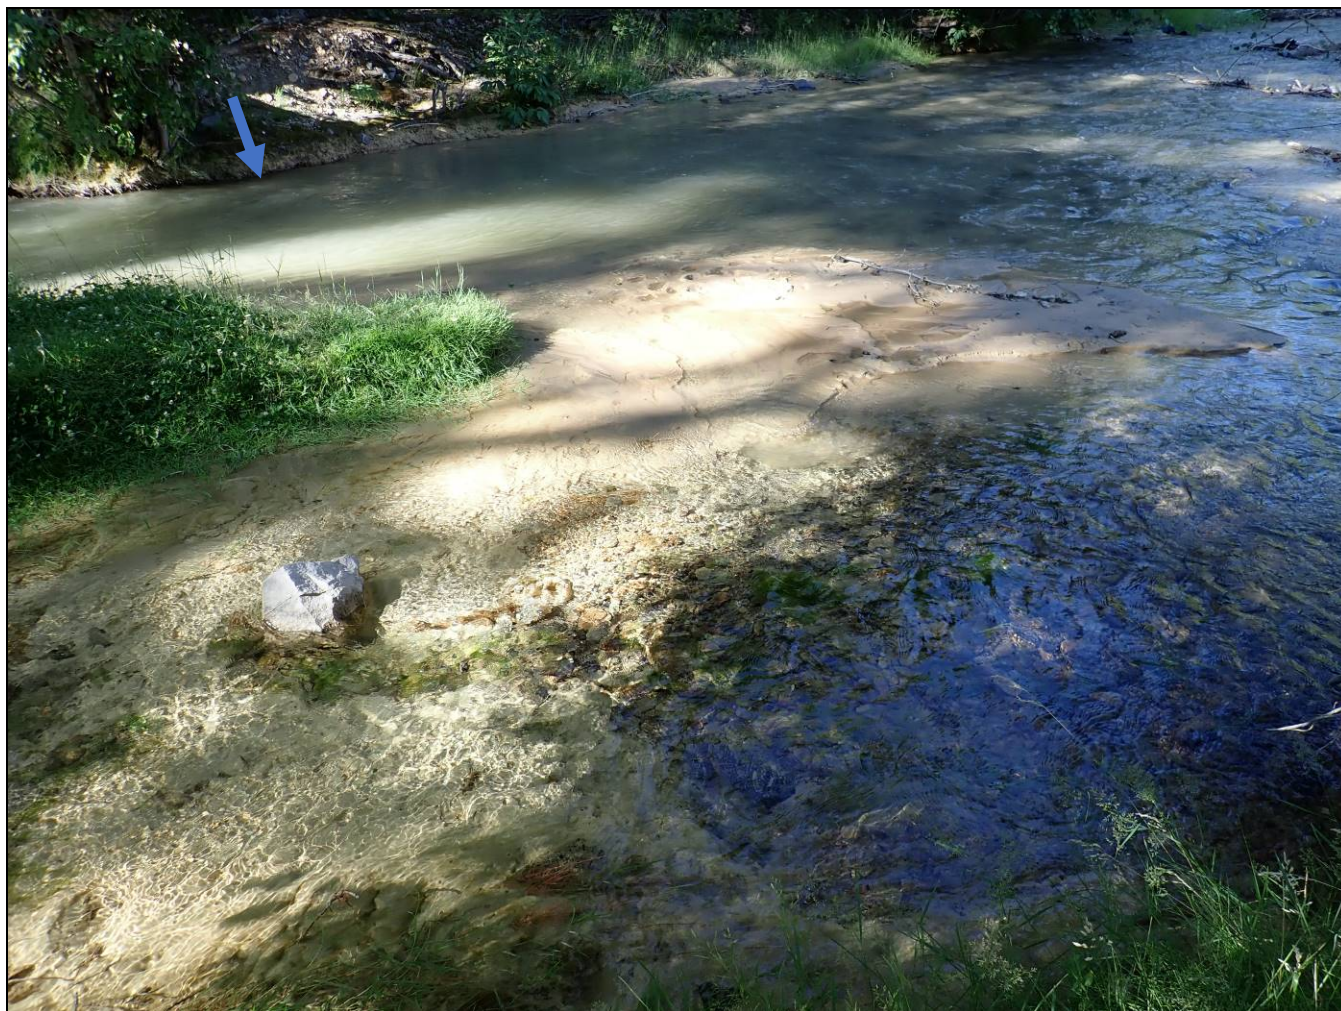
**NMED/SWQB
Official Photograph Log
Photo # 7**

Location: CMI Questa Mine, Water Treatment Plant, Mine Site

Subject: Looking at Red River downstream near Outfall 001 at the confluence of shallow side channel (foreground) and Red River (background). Arrow points to Red River which appeared turbid at this location. The effluent in the side channel was clear. Algal growth was observed in the side channel.

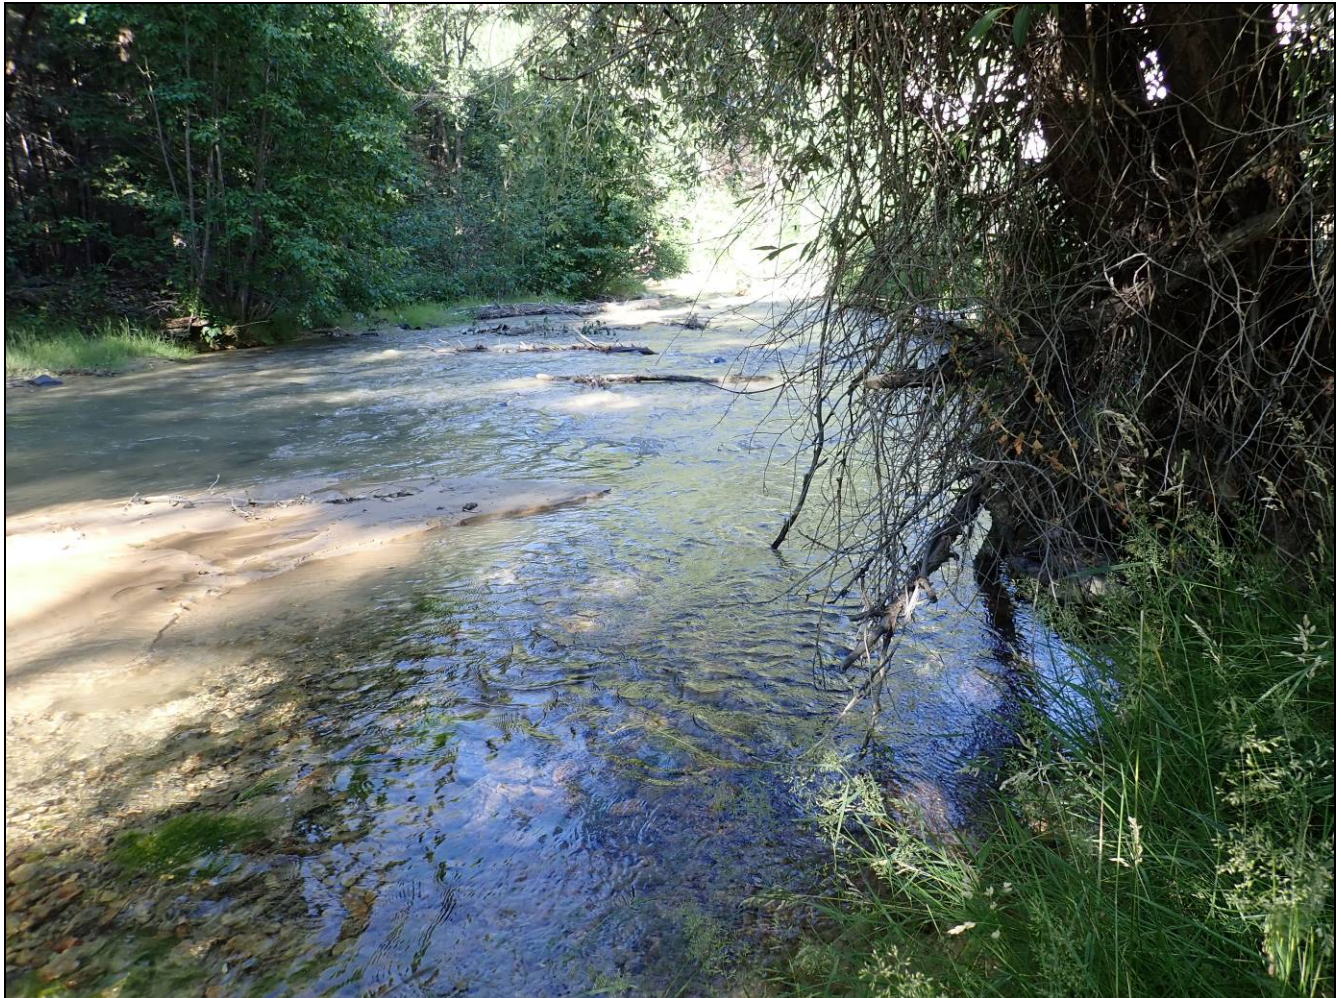
**NMED/SWQB
Official Photograph Log
Photo # 8**

Location: CMI Questa Mine, Water Treatment Plant, Mine Site

Subject: Looking west at Red River downstream of Outfall 001 and side channel confluence.

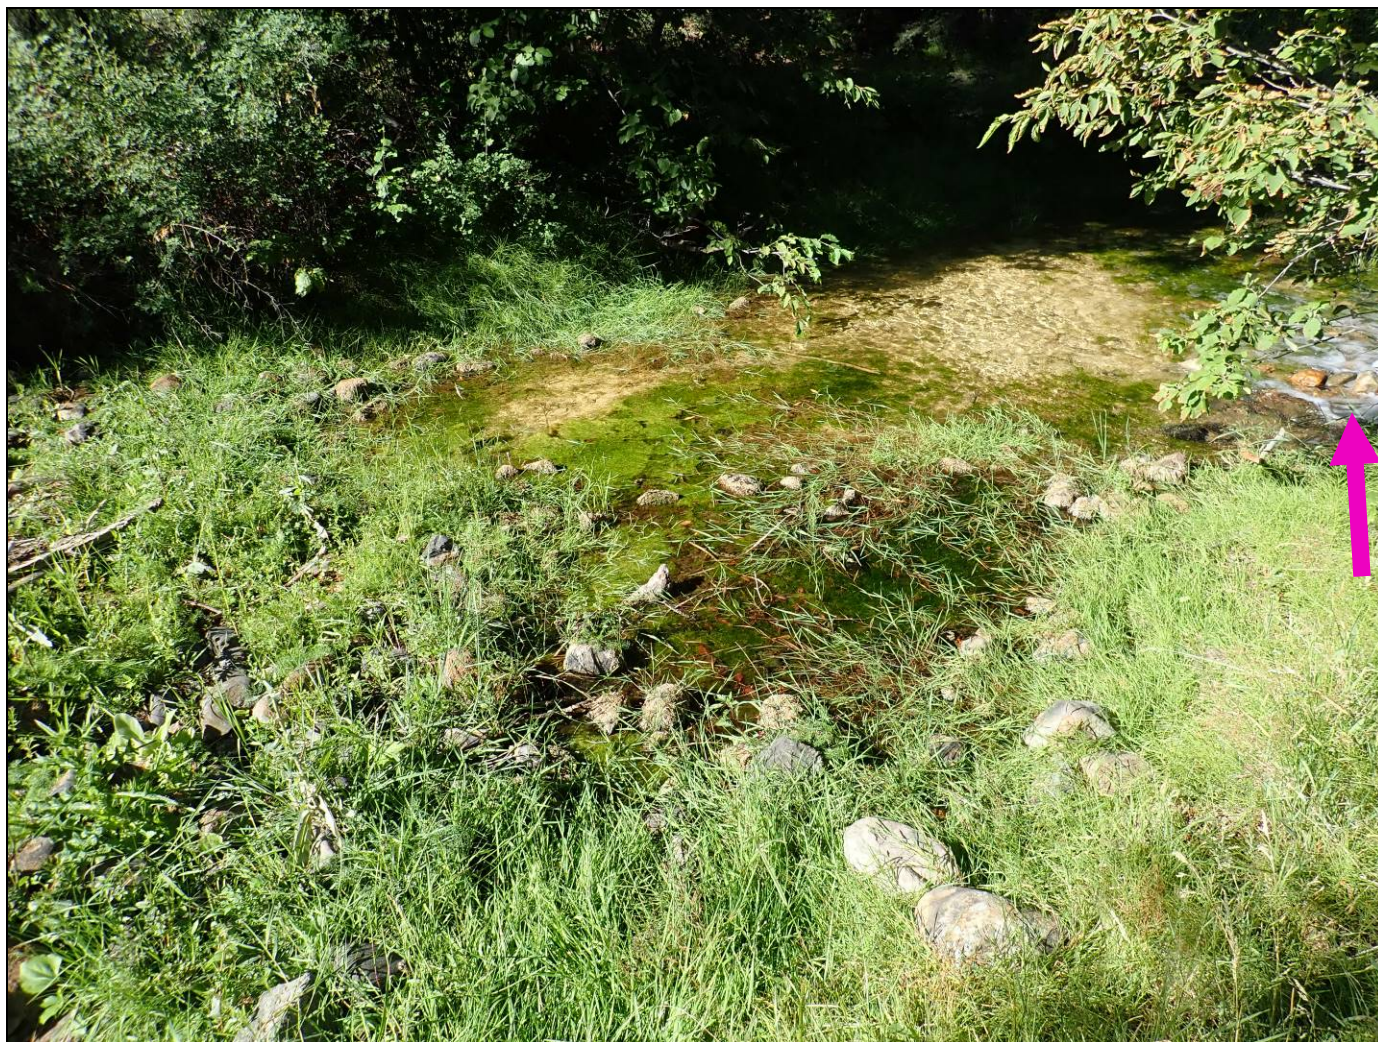
**NMED/SWQB
Official Photograph Log
Photo # 9**

Location: CMI Questa Mine, Water Treatment Plant, Mine Site

Subject: Algal growth in side channel at and above Outfall 001 discharge. Arrow points to Outfall 001 discharge entering side channel.
